**Archaeological Monitoring  
the Demolition and Dismantling-  
Commemoration Project, Marshall Lime Kilns,  
Upper James and Red Hill Expressway,  
Regional Municipality of Hamilton, Ontario**

Submitted to  
**Regional Municipality of Hamilton-Wentworth  
Hamilton, Ontario**

**ARCHAEOLOGICAL SERVICES INC.**  
662 Bathurst Street  
Toronto, Ontario

December 1994

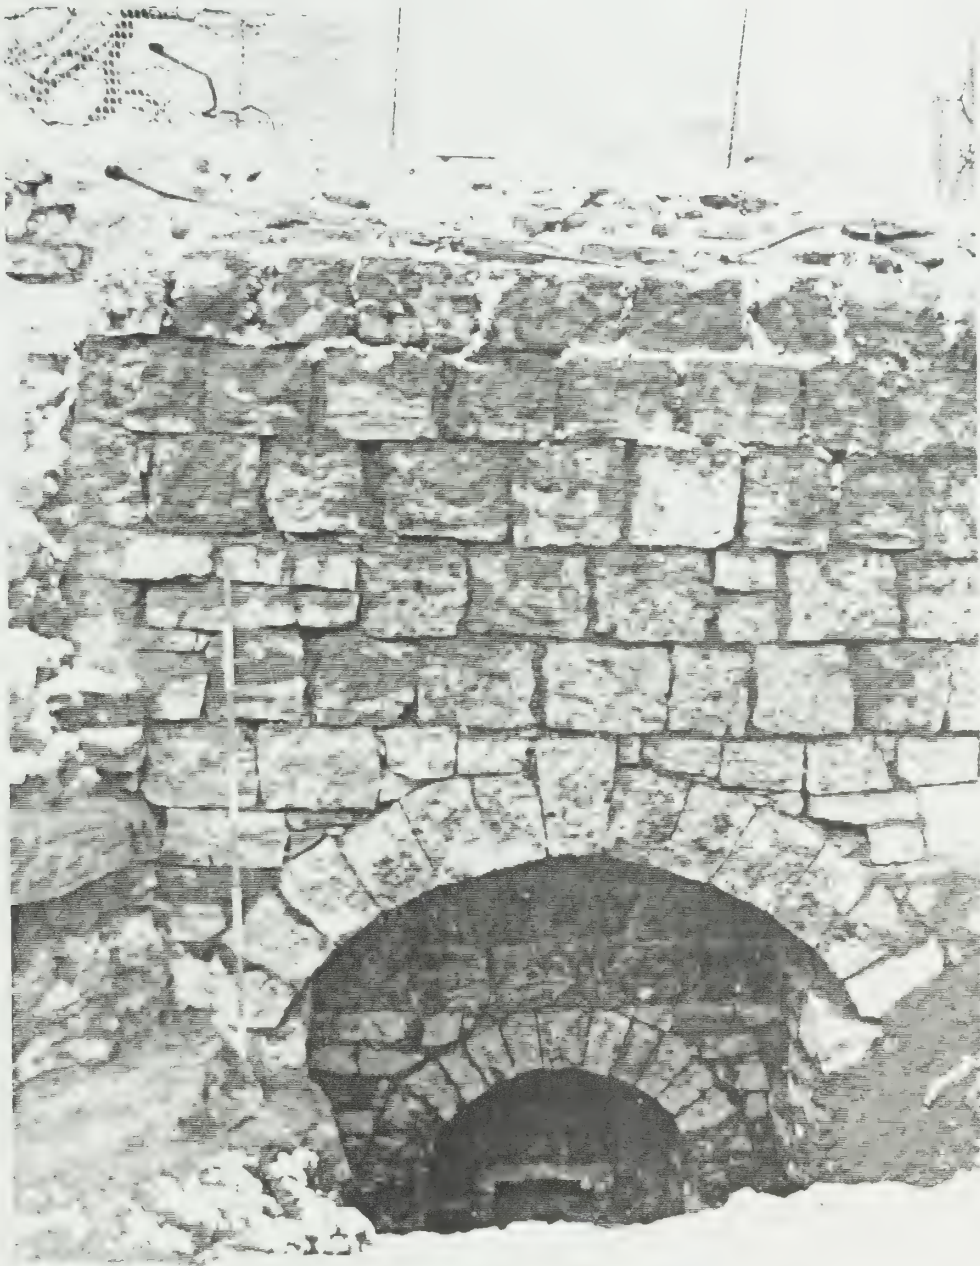
**Plate 1: Kiln One**

Front, east side of the kiln, showing maximum height of the kiln as found and the access arch and draw hole, Nov. 25, 1991. Bedrock outcropping is visible just to the left of the range rod.

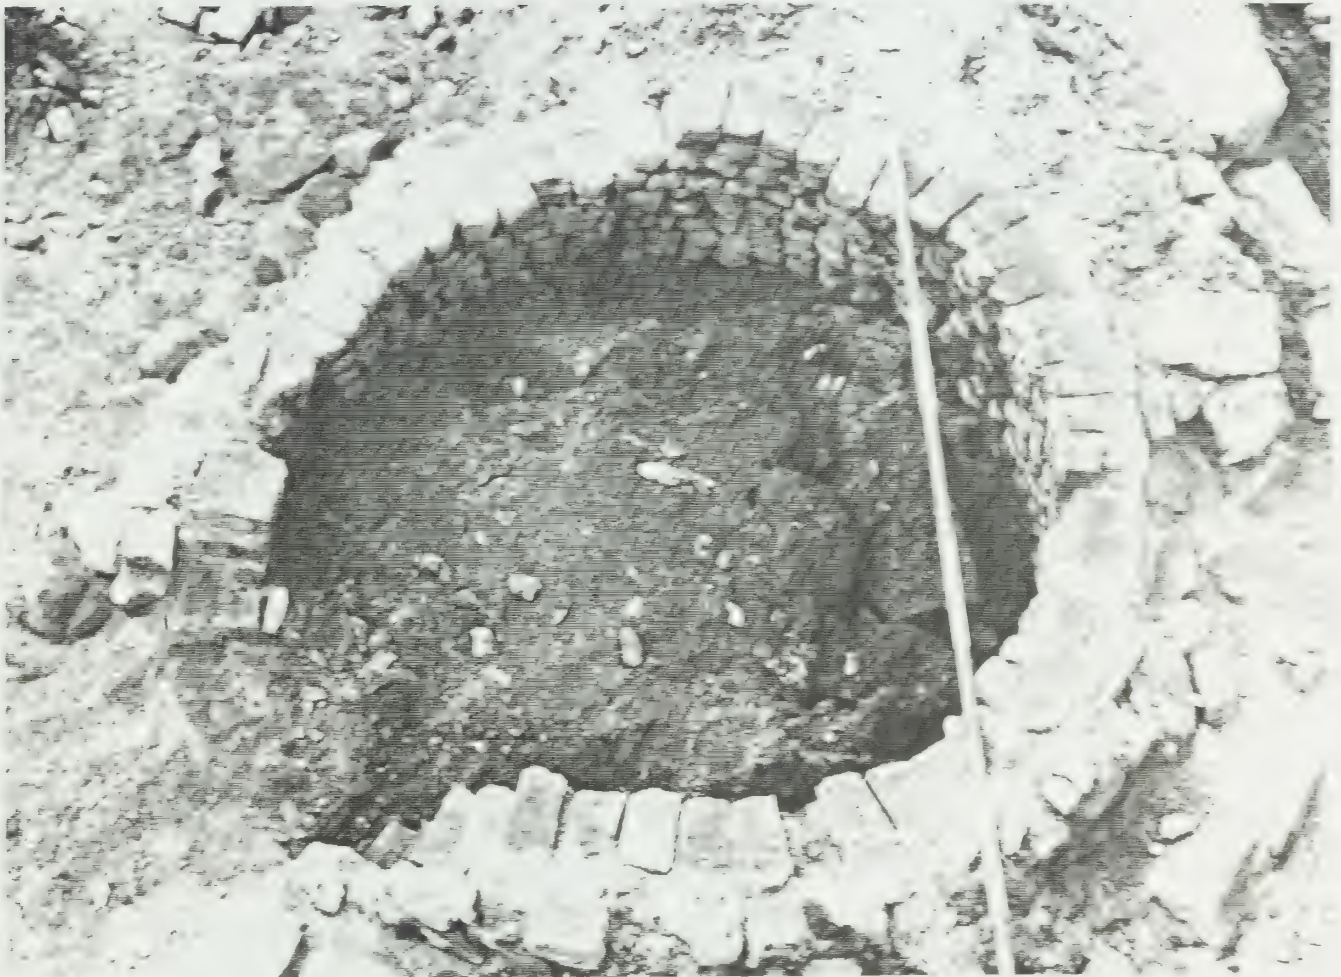
**Plate 2: Kiln One - Stack**

Looking down on the kiln at the top of the structure as found, June 29, 1994. The break in the lining at the lower left was made to remove fill from inside of the stack. Retaining wall (west side) is on the right.

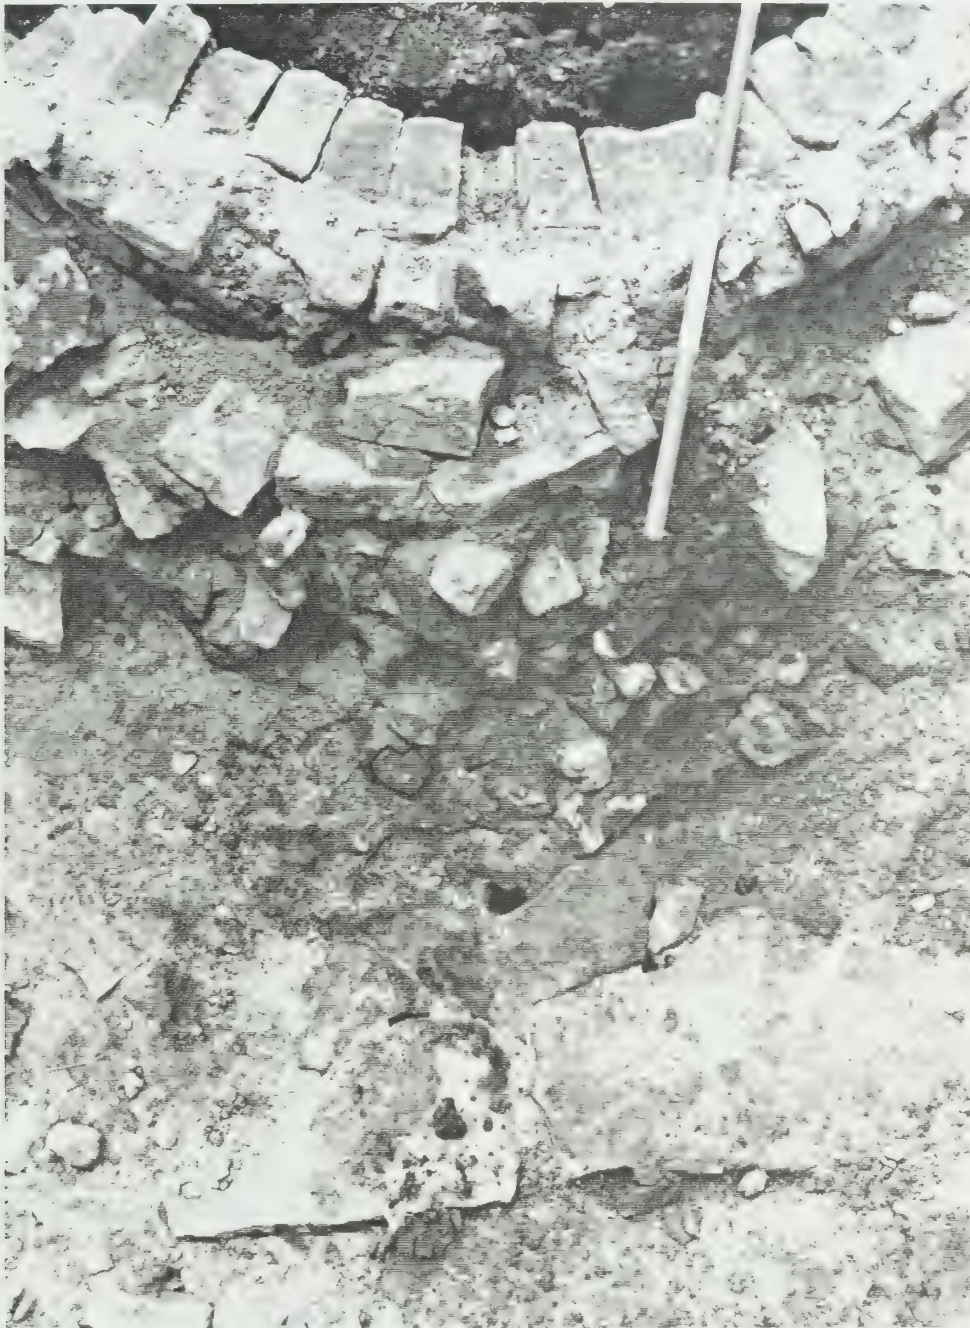
**Plate 3: Kiln One - Stack**

Retaining wall, fill in body of the kiln and refractory brick lining at the top, June 28, 1994. This shows the lining, mortar layer and rubble fill found near the top of the excavation. Note also the porosity of the body fill as demonstrated by the dark hole near the middle of the photograph, adjacent to the retaining wall.

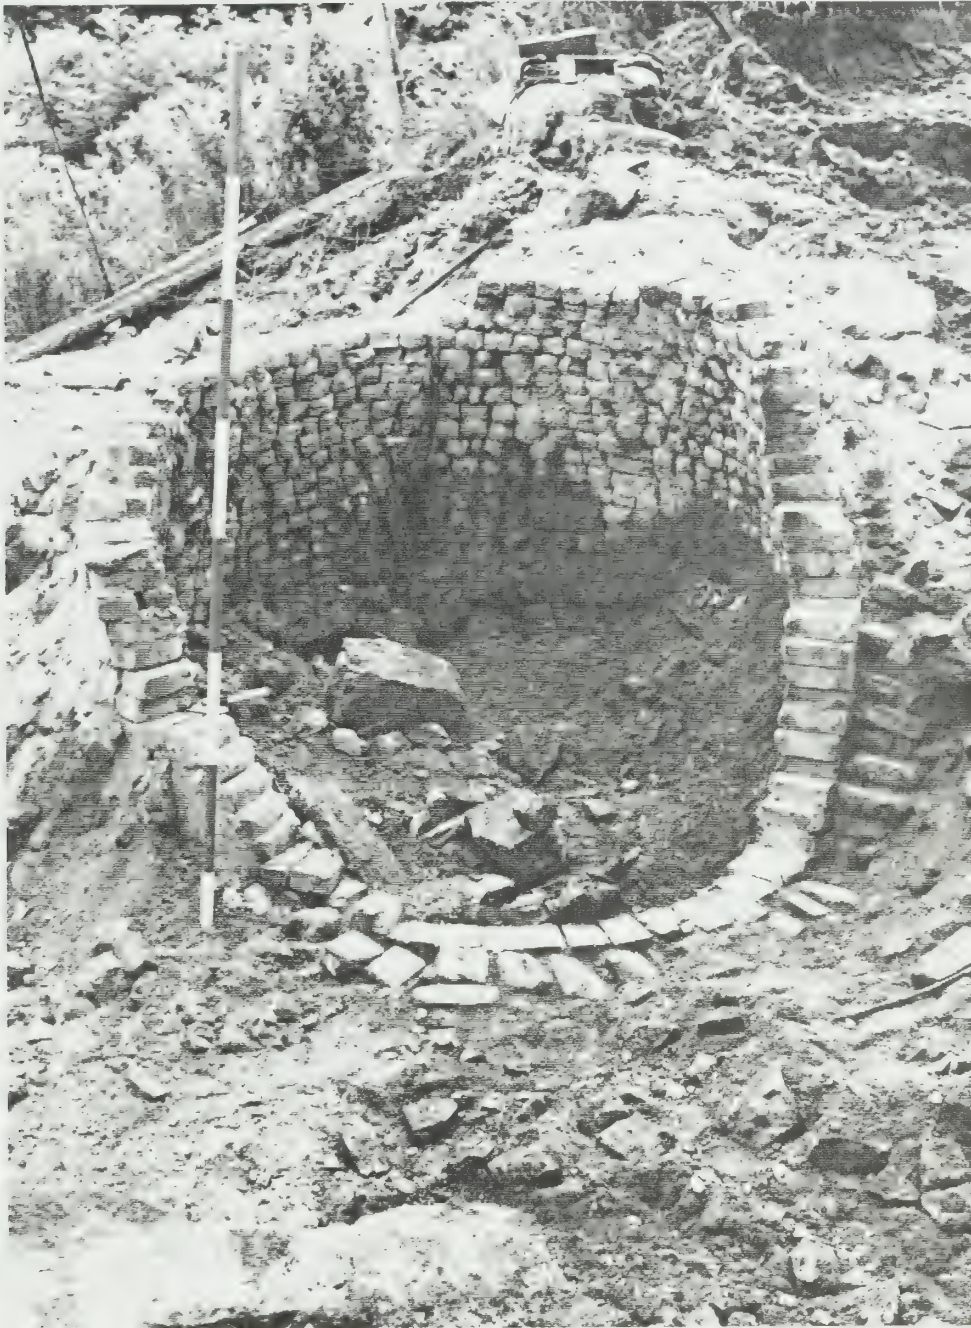
**Plate 4: Kiln One - Stack**

Kiln stack looking south, June 28, 1994. While the retaining wall holding back the earth bank is on the right, a small portion of the facing blocks on the north kiln wall are visible in the lower left. The double layer of refractory brick lining can be seen on the right. First quality brick lines the stack and was backed by second quality brick.

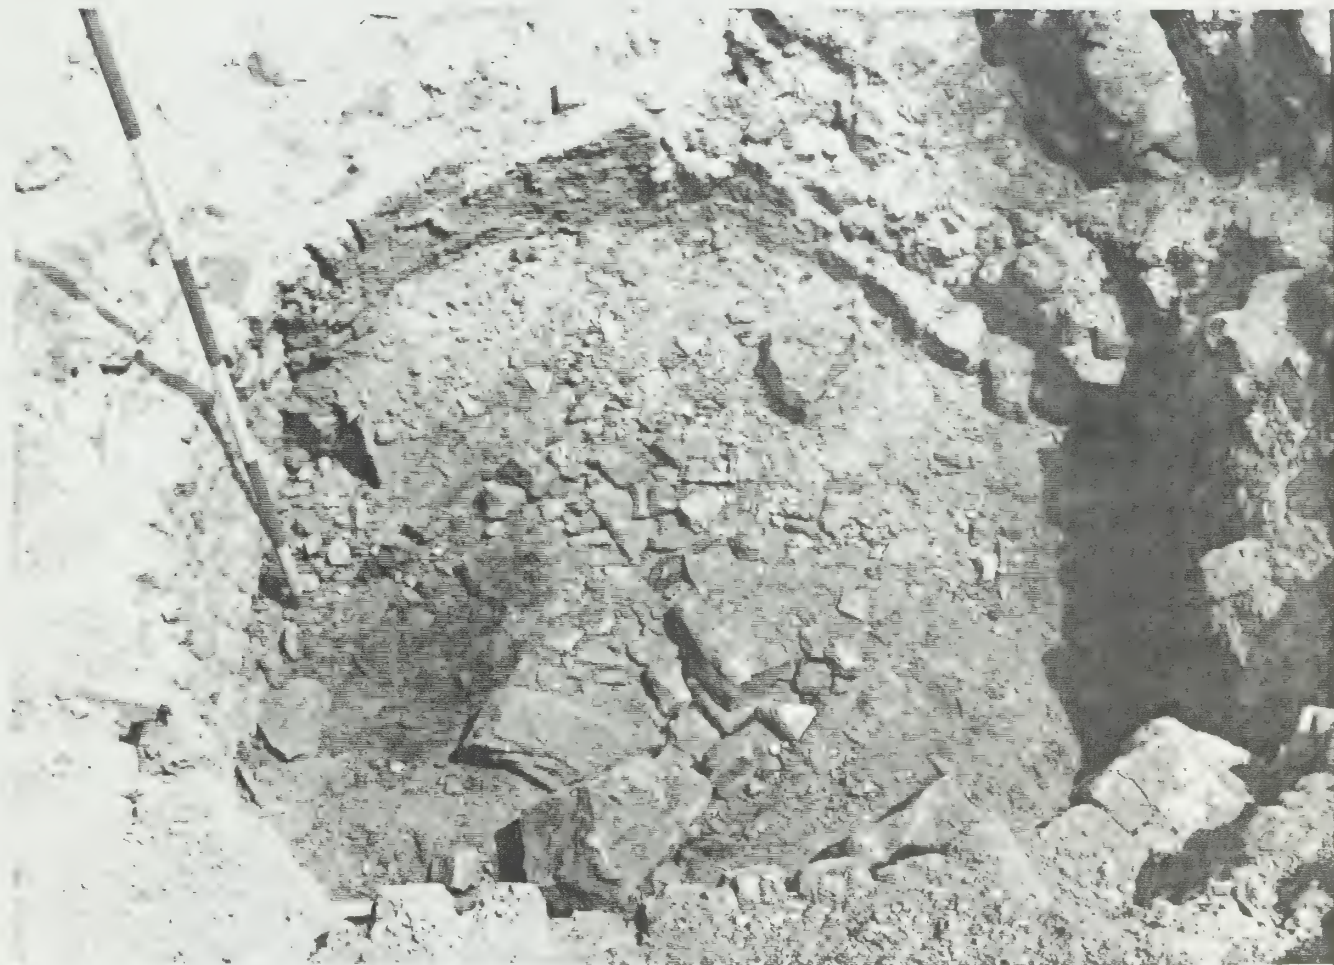
**Plate 5: Kiln One - Stack**

Burn-out in refractory brick lining at the upper right of the photo, July 4, 1994. A small area adjacent to the south furnace (on right) contained tunnels of vitrified material extending about a foot into the body of the kiln. The large lime deposit in the kiln body was located behind the range rod.

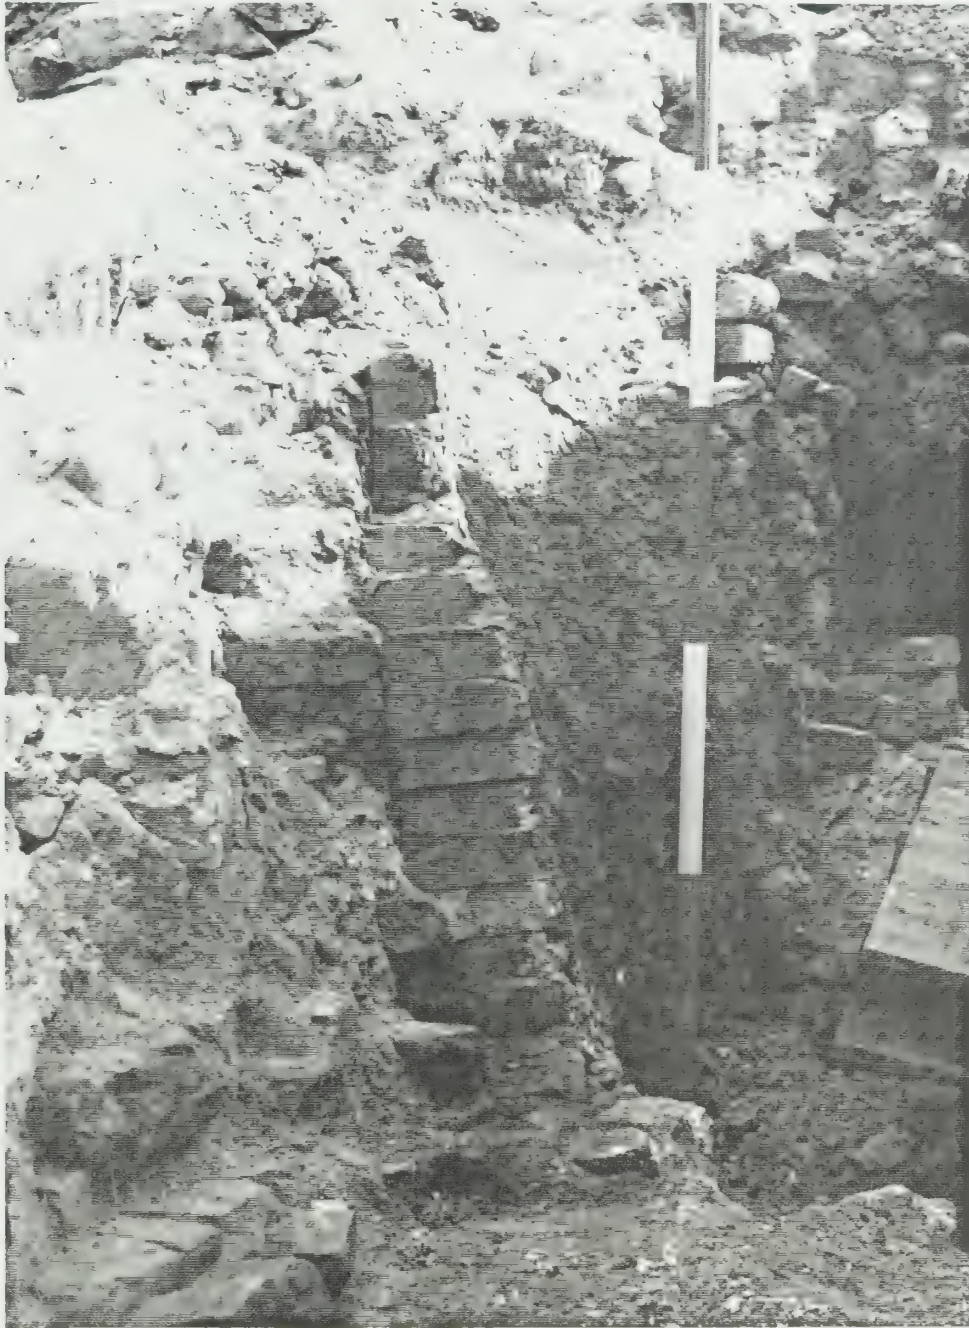
**Plate 6: Kiln One - Stack**

Stack lining on the east (front) of the stack showing the profile of the kiln - the range rod is vertical - at the level of the firebox, July 5, 1994. The hearth floor of the north firebox is just visible at the bottom of the photo and the south furnace is the dark hole at the right. The refractory lining bricks are almost the full thickness beneath the hearth level and have been almost completely burned away near the top. The burn-out [Plate 5] occurred in this vicinity.

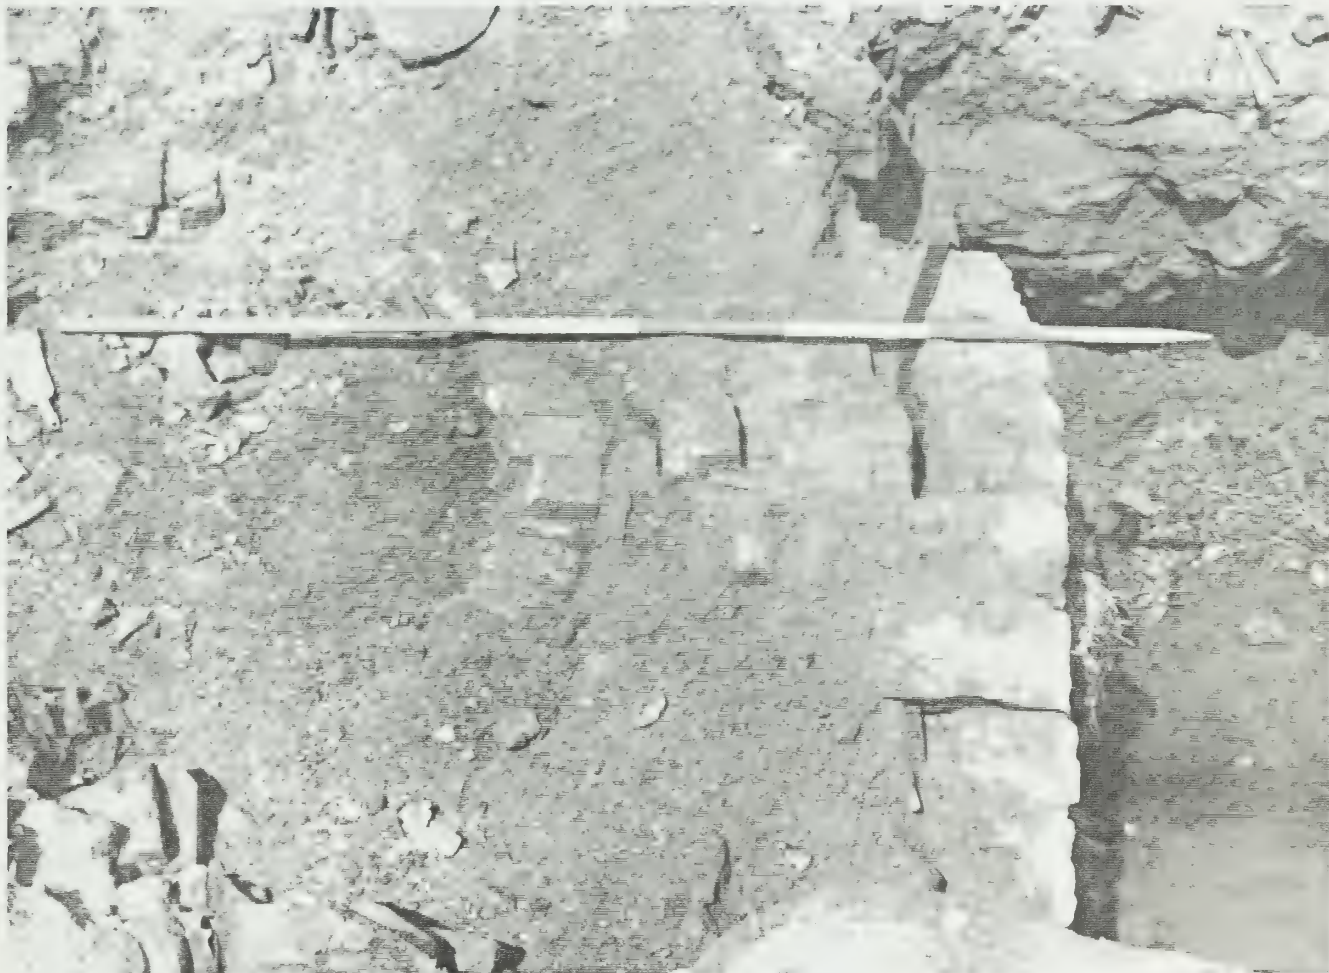
**Plate 7: Kiln One - Stack**

Looking down onto the kiln, July 7, 1994. Stack, on left, across the stack lining, body fill and key stone and arch of the lower access arch into the working area, on right, in front of the draw hole (not visible). The keystone is the large block below the range rod and disappearing into the kiln body.

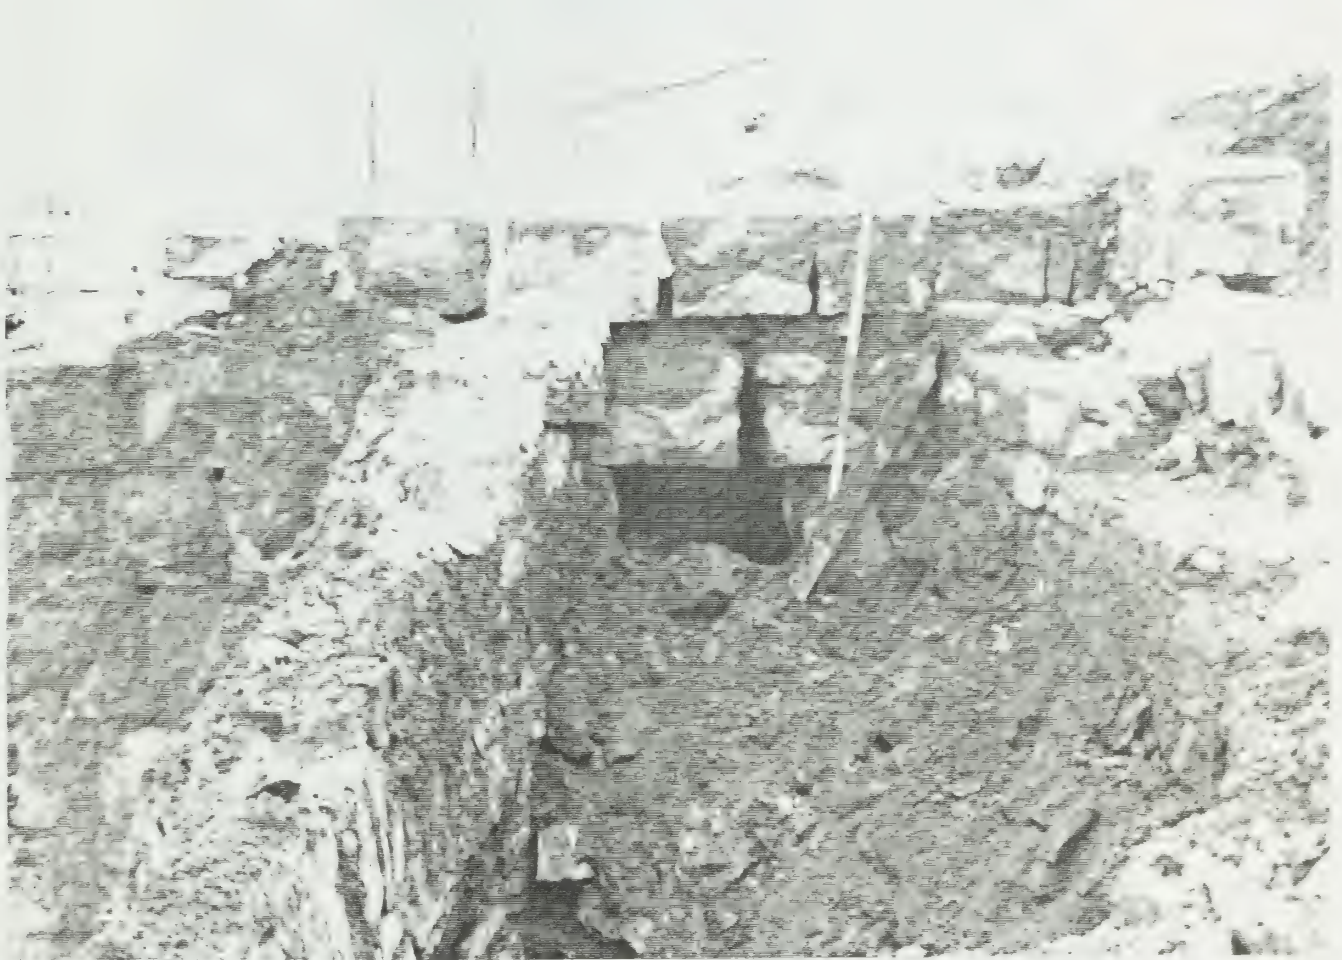
**Plate 8: Kiln One - North Furnace**

North kiln wall above the firing chamber showing poor condition of the face stones, Nov. 25, 1991. The retaining wall of the north firing chamber is on the right, the exterior wall of the chamber is on the left.

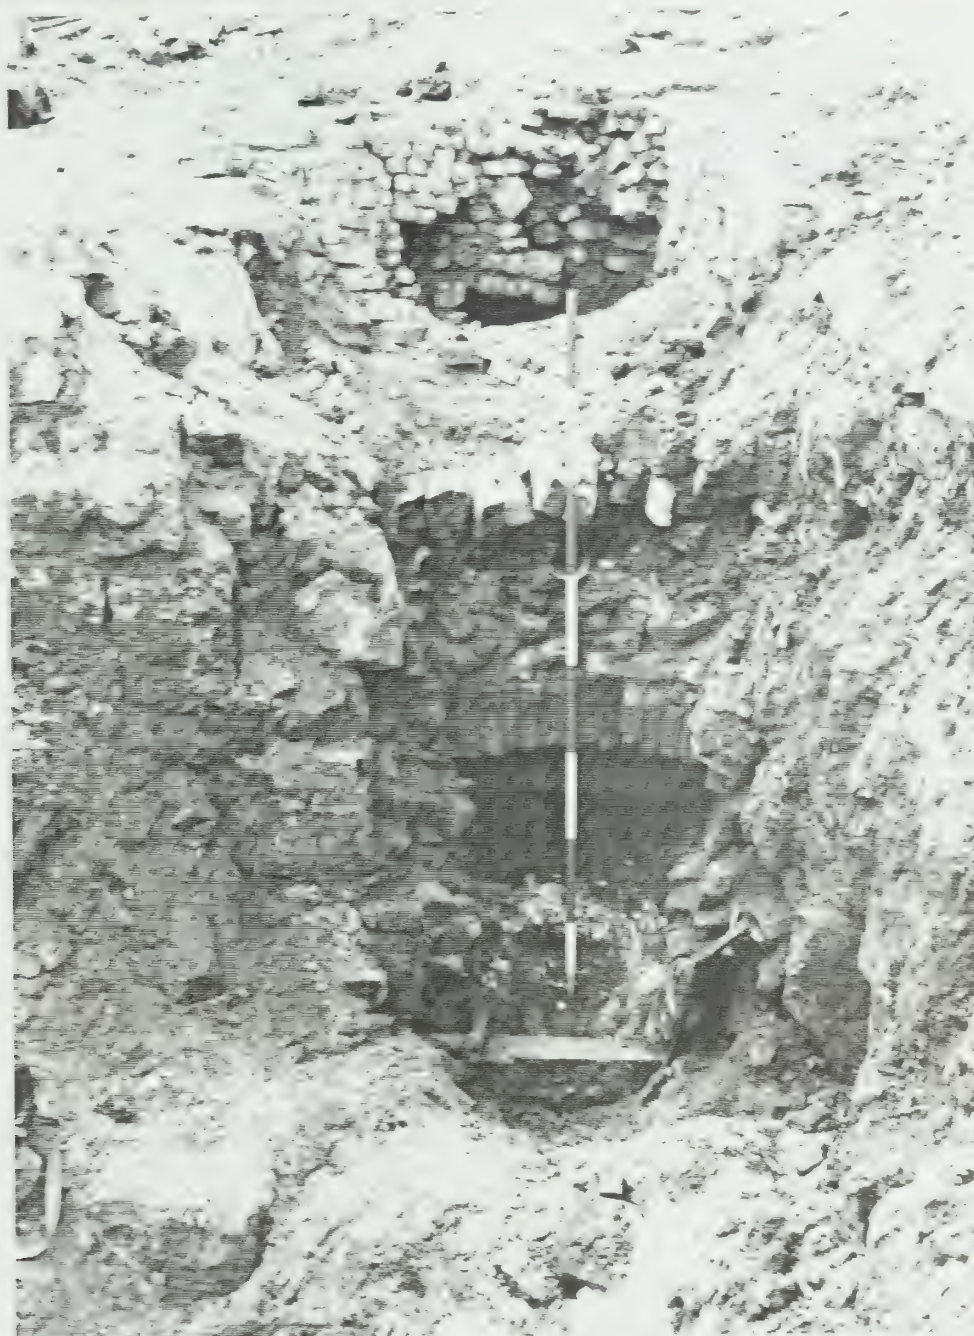
**Plate 9: Kiln One - North Furnace**

North furnace prior to removal of the arch and stack lining, June 30, 1994. The block held by the iron pin [Plates 11, 12] is immediately to the left of the furnace. The range rod is resting on the iron base of the firebox door and one of the jambs is at an angle to the right of the rod. The actual roof of the firebox is the dark, inner brick lining. The second arch abuts the range rod. The brick fill containing the pipes - one is directly behind the range rod - sits on top of the brick arch. The stone relieving arch is near the top of the range rod. The kiln stack is in the rear and the poor condition of the lining above the south furnace is visible.

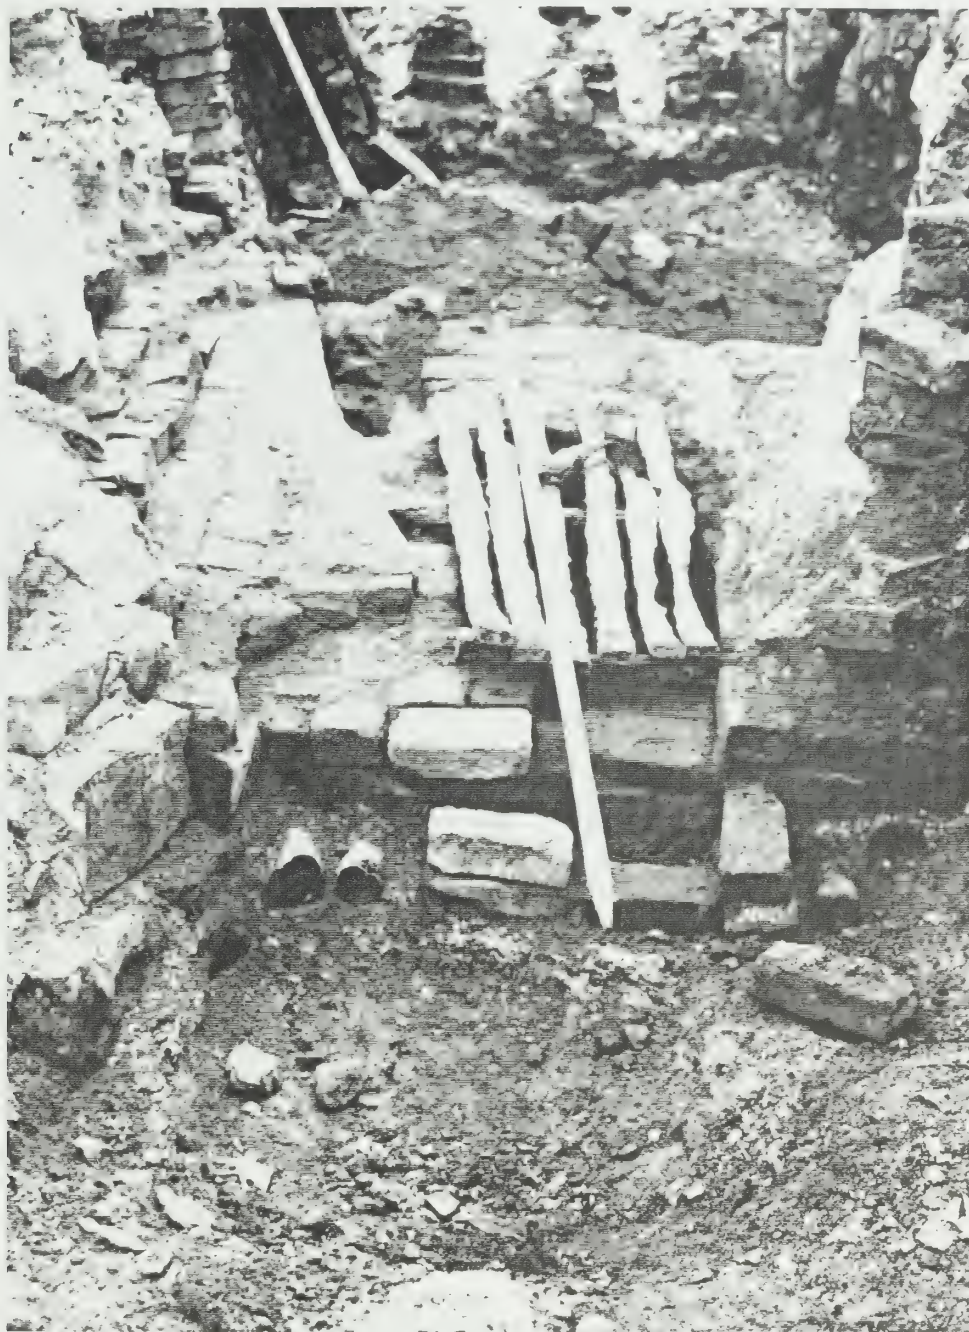
**Plate 10: Kiln One - North Furnace**

Firebox entrance after excavation of the ashbox and replacement of the firebox grates, July 6, 1994. Notice the warp in the grate bars. The pipes of unknown function lie at the work floor level in the front of the kiln. The mouth of the south furnace is just visible at the top of the plate.

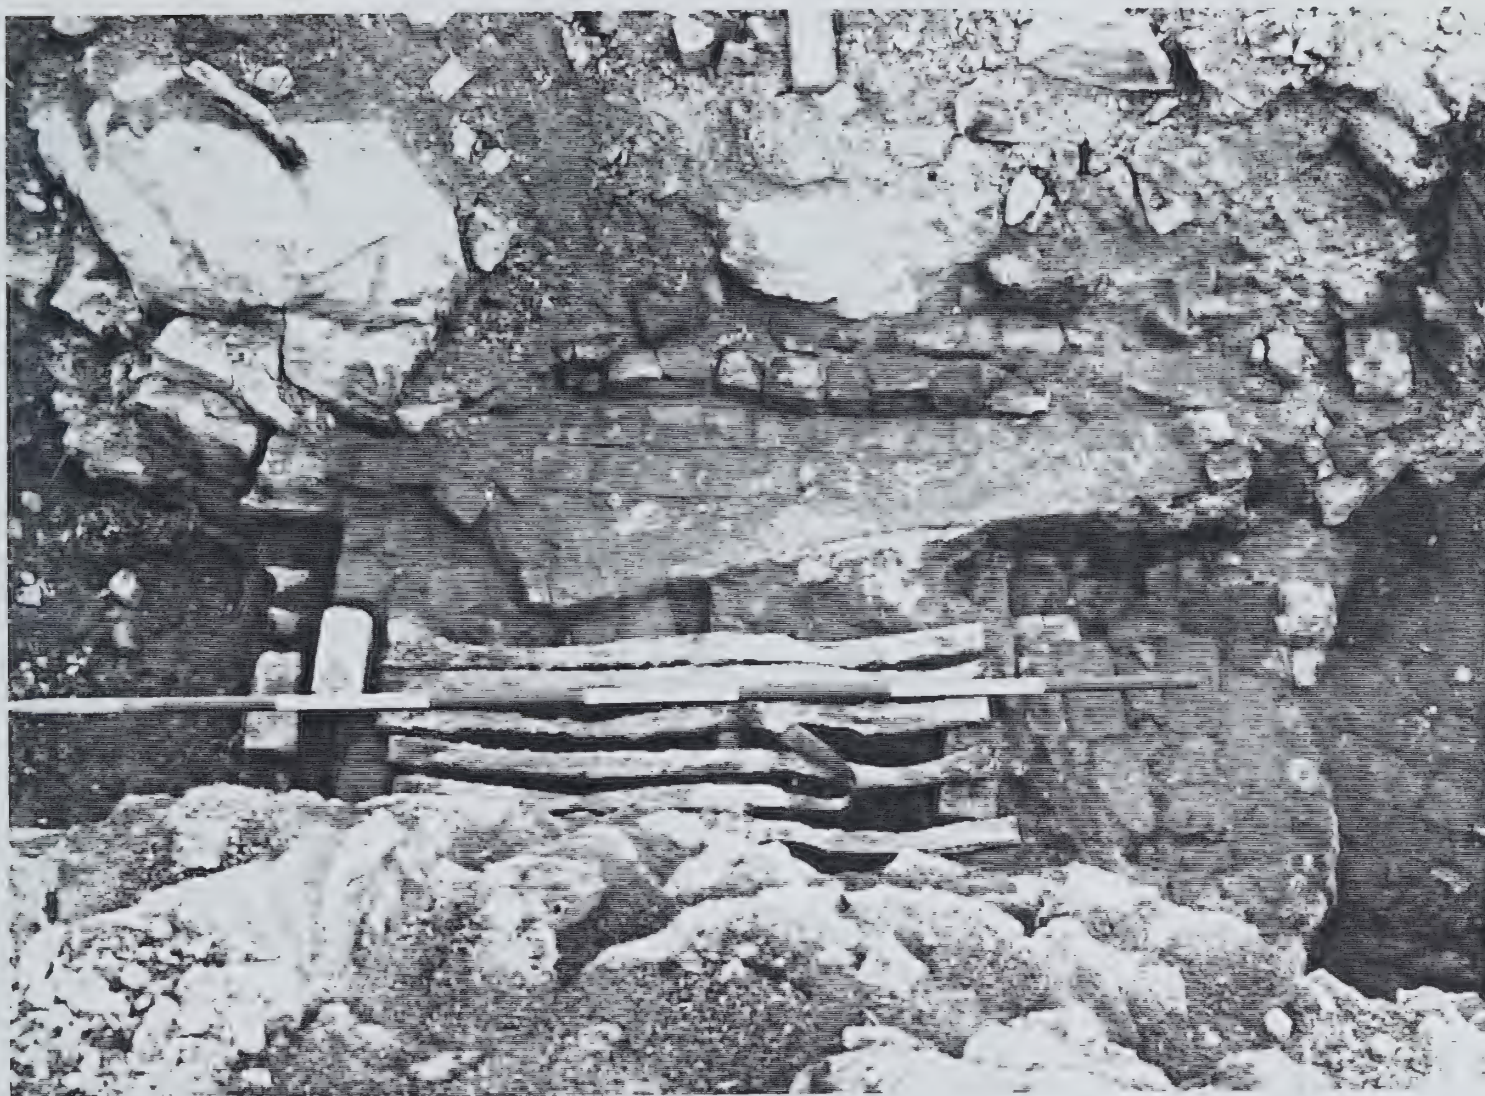
**Plate 11: Kiln One - North Furnace**

Looking down on the firebox after excavation of the ashpit and replacement of the grate bars, July 6, 1994. Photo taken from on top of the retaining wall on the west side with the front of the firebox on the left and the stack on the right. Note the V-shape of the firebox. The parallel rows of brick above the grates was fill between the furnace and the bedrock. The iron pin [Plate 12] is visible at upper left. The pillars in Plate 14 were removed during the excavation of the hearth. The distance between the ashbox and stack lining provided a bridge area.

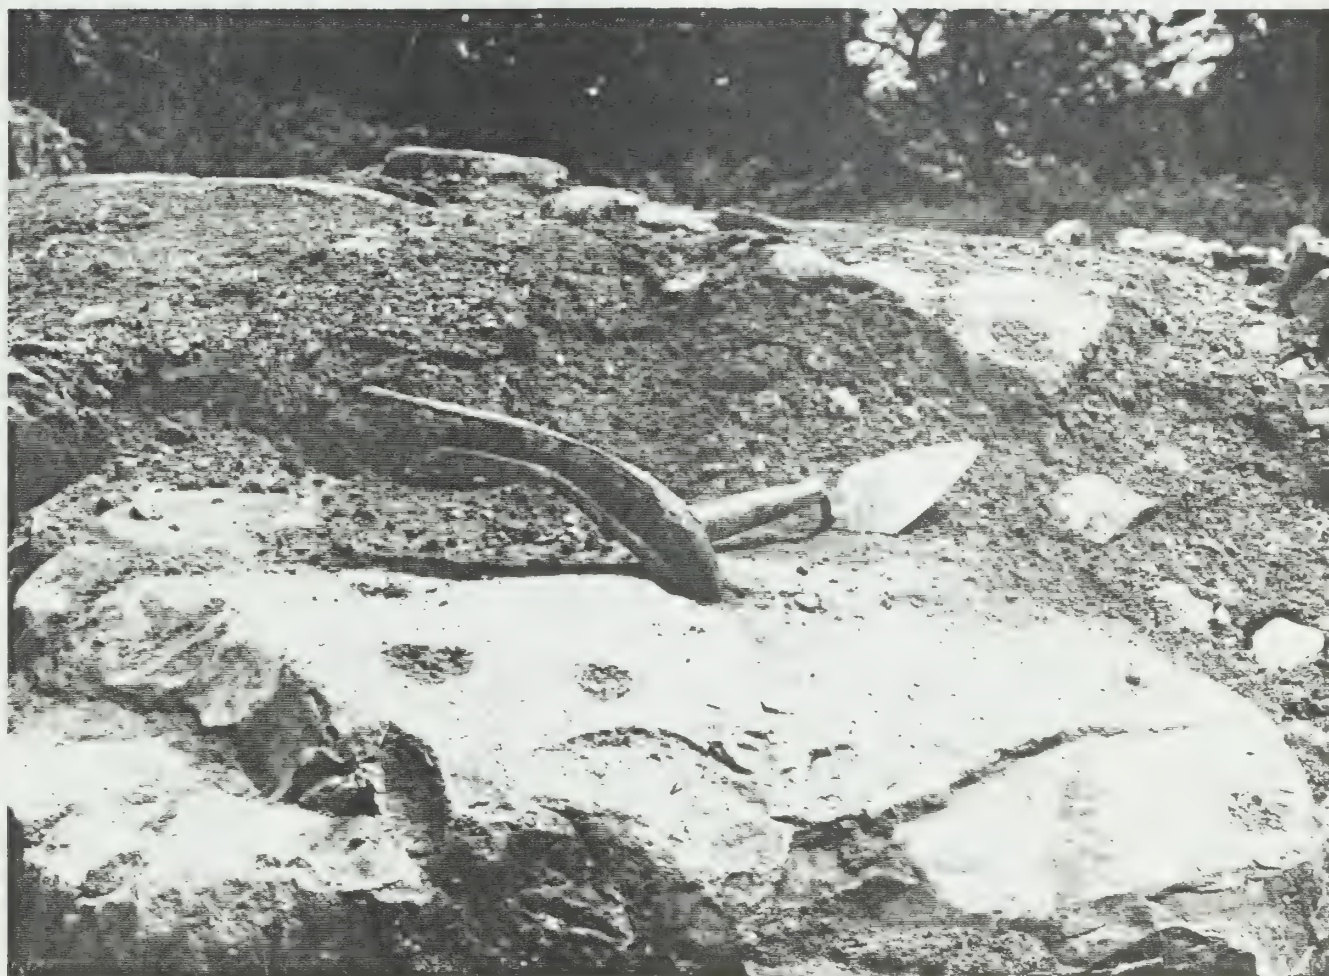
**Plate 12: Kiln One - North Furnace**

Wrought iron pin inserted into the drill hole in the bedrock to hold the exterior face blocks of the kiln, July 6, 1994. Located on the left (east) side of the north firebox door.

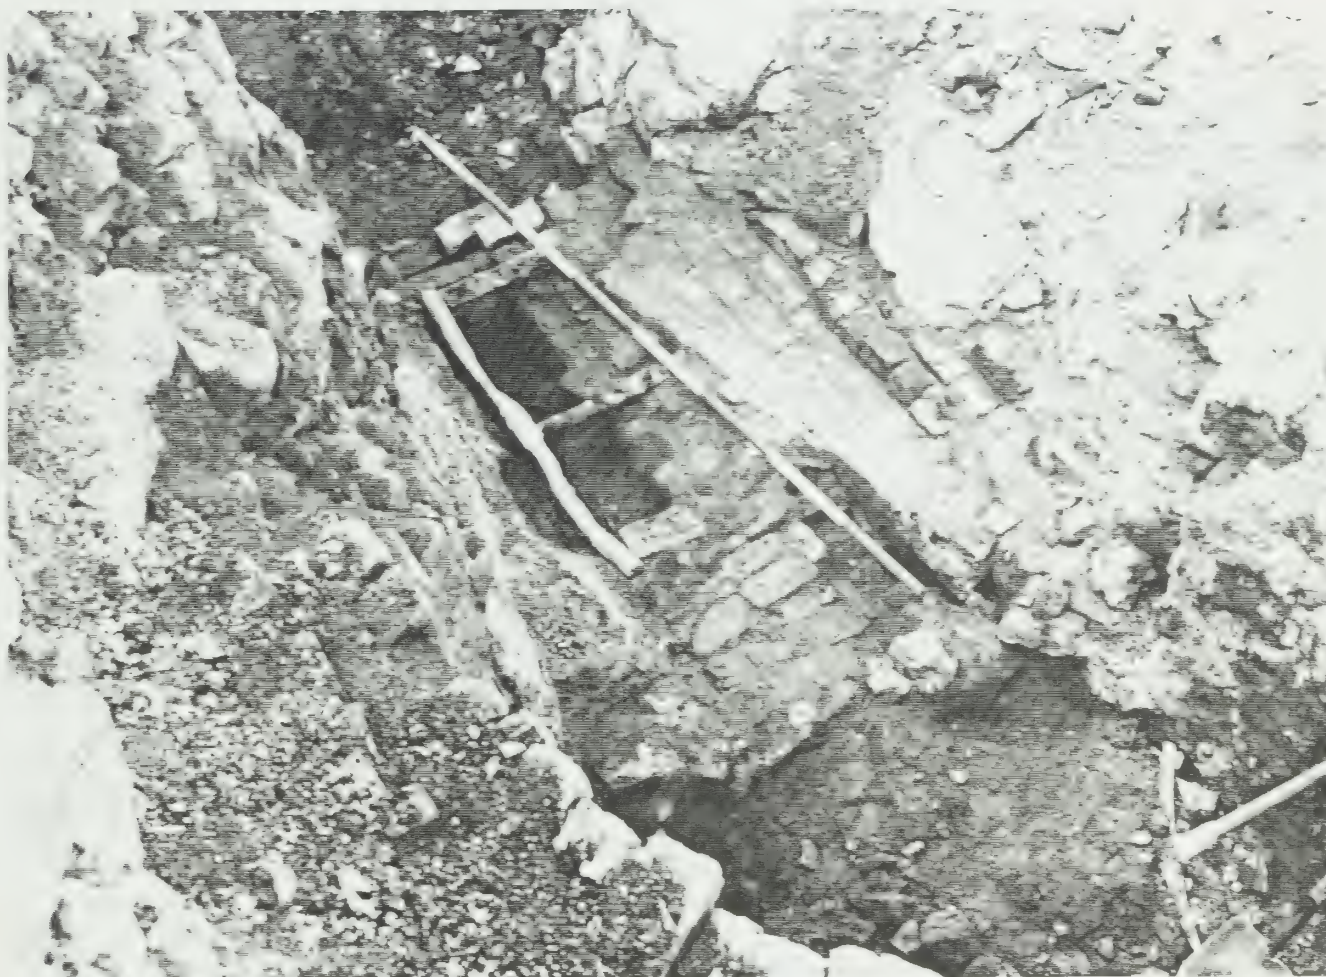
**Plate 13: Kiln One - North Furnace**

North furnace after excavation of the ashpit, July 6, 1994. Kiln stack at bottom. One metal grate has been replaced over the ashbox. The pillars at the mouth of the furnace [Plate 14] have been removed.

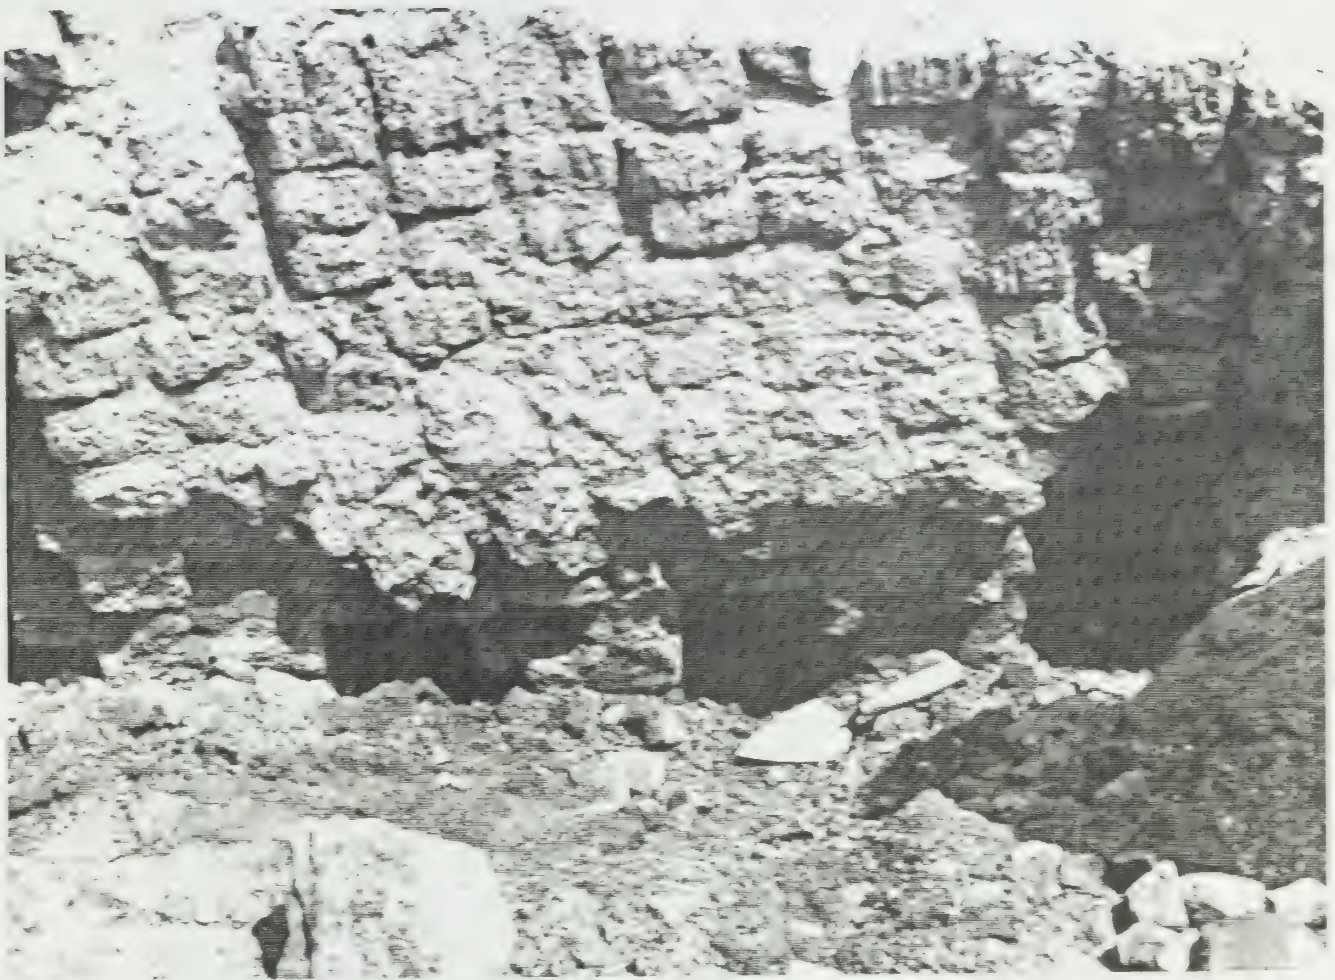
**Plate 14: Kiln One - North Furnace**

Looking from the stack towards the pillars of the north furnace, July 4, 1994. Lower part of the furnace is still unexcavated.

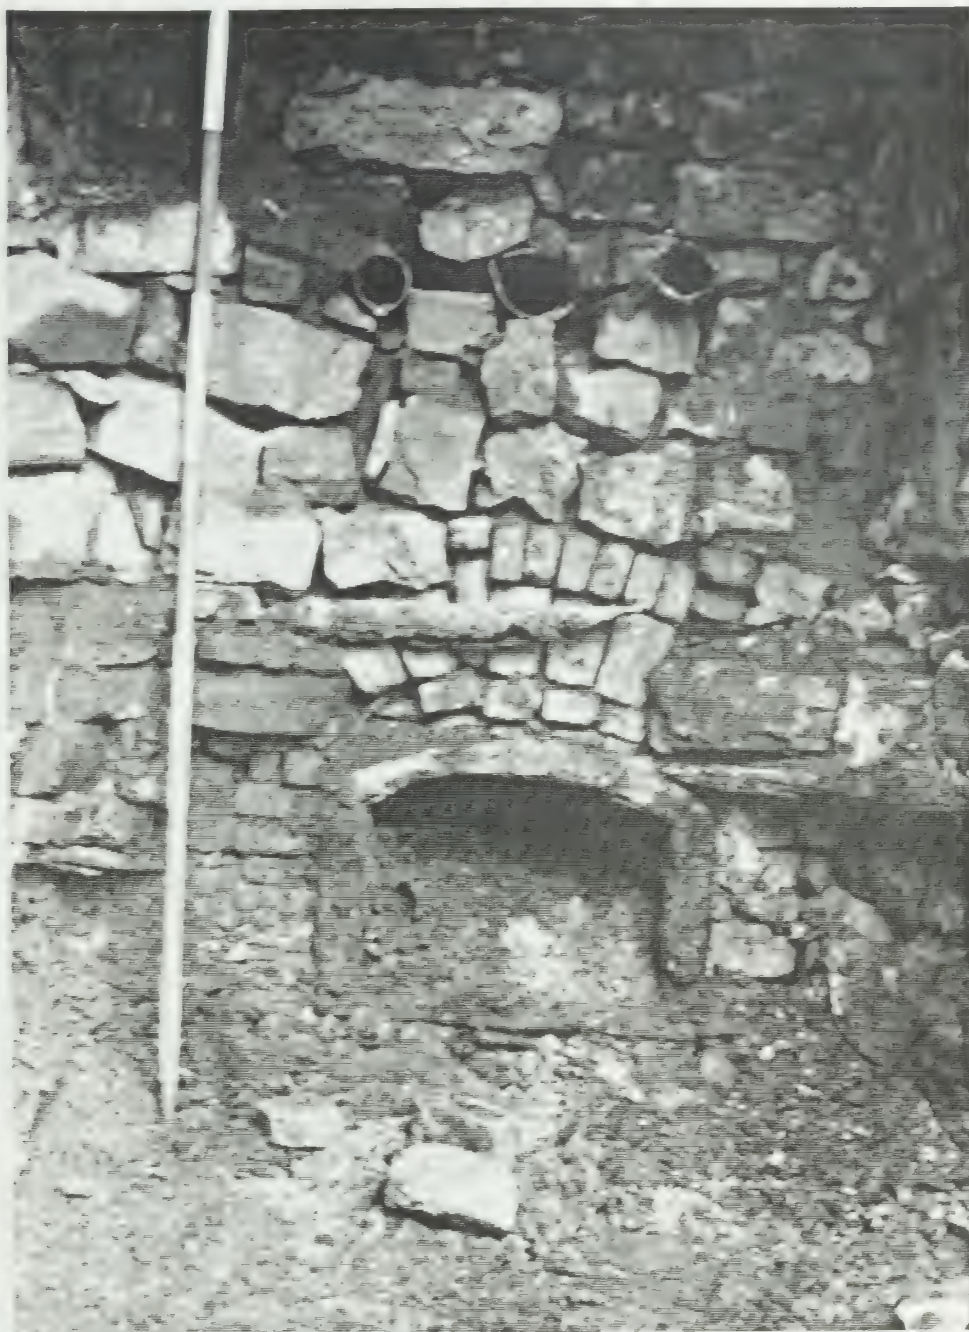
**Plate 15: Kiln One - South Furnace**

The south furnace entrance showing the brick arch, three air pipes or poke holes and the Horizontal metal pipe just above the firebox door, Nov. 25, 1991.

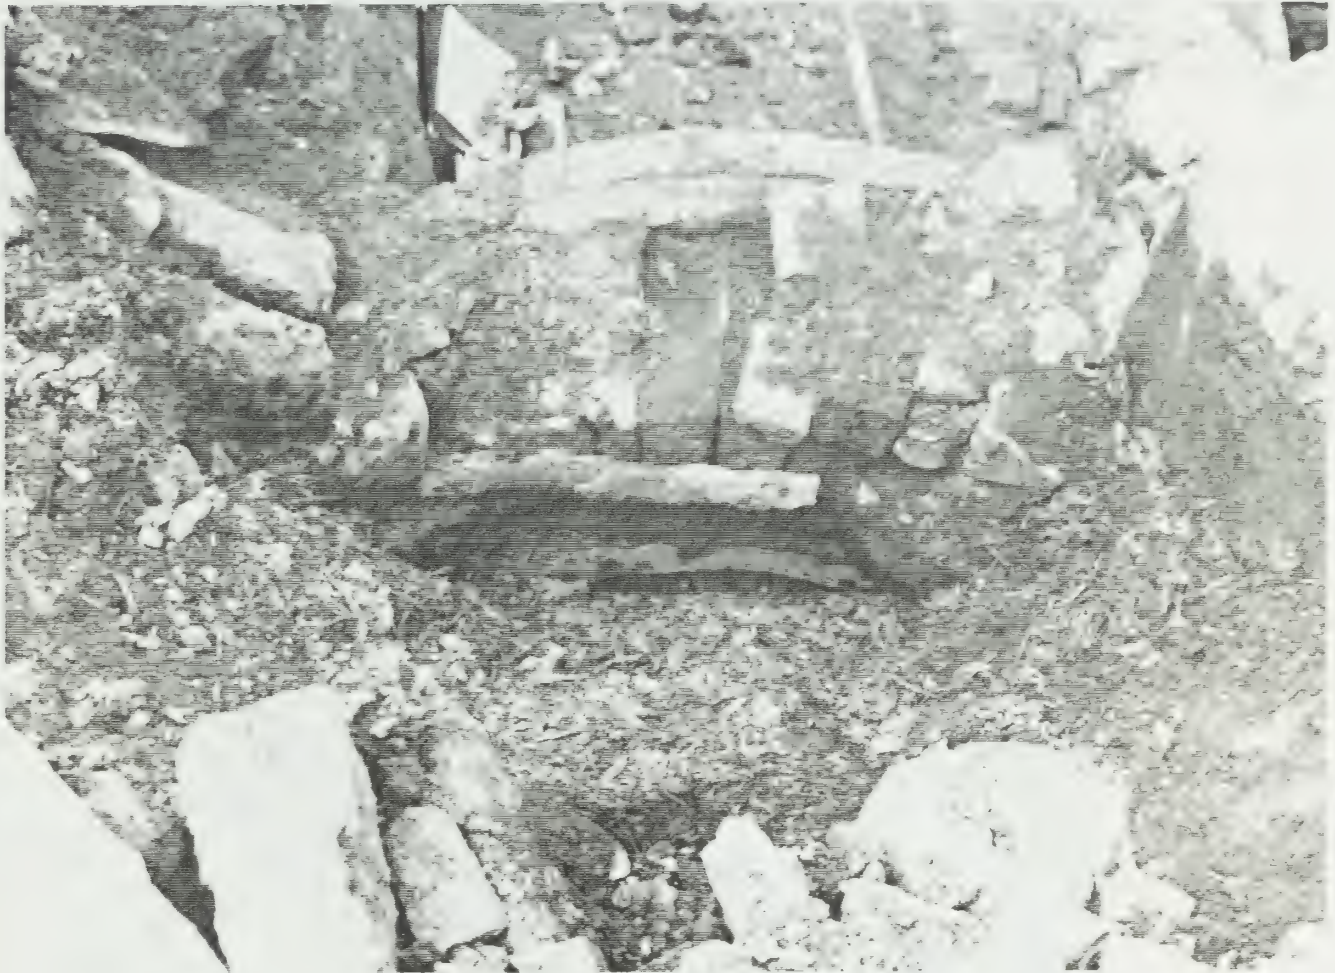
**Plate 17: Kiln One - South Furnace**

South furnace showing the brick arch at the front, July 7, 1994. Note the change in the brick arch construction. Bedrock is on the right. The top of the firebox door and the horizontal metal pipe are just visible near the middle of the plate. Straw was placed in front of the furnace following the 1991 excavation.
